CC8 Bulk Rolls

Cloudhill Quarry,
Derby, UK

CC trialled as an alternative to shotcrete in providing surface erosion protection to sandstone.

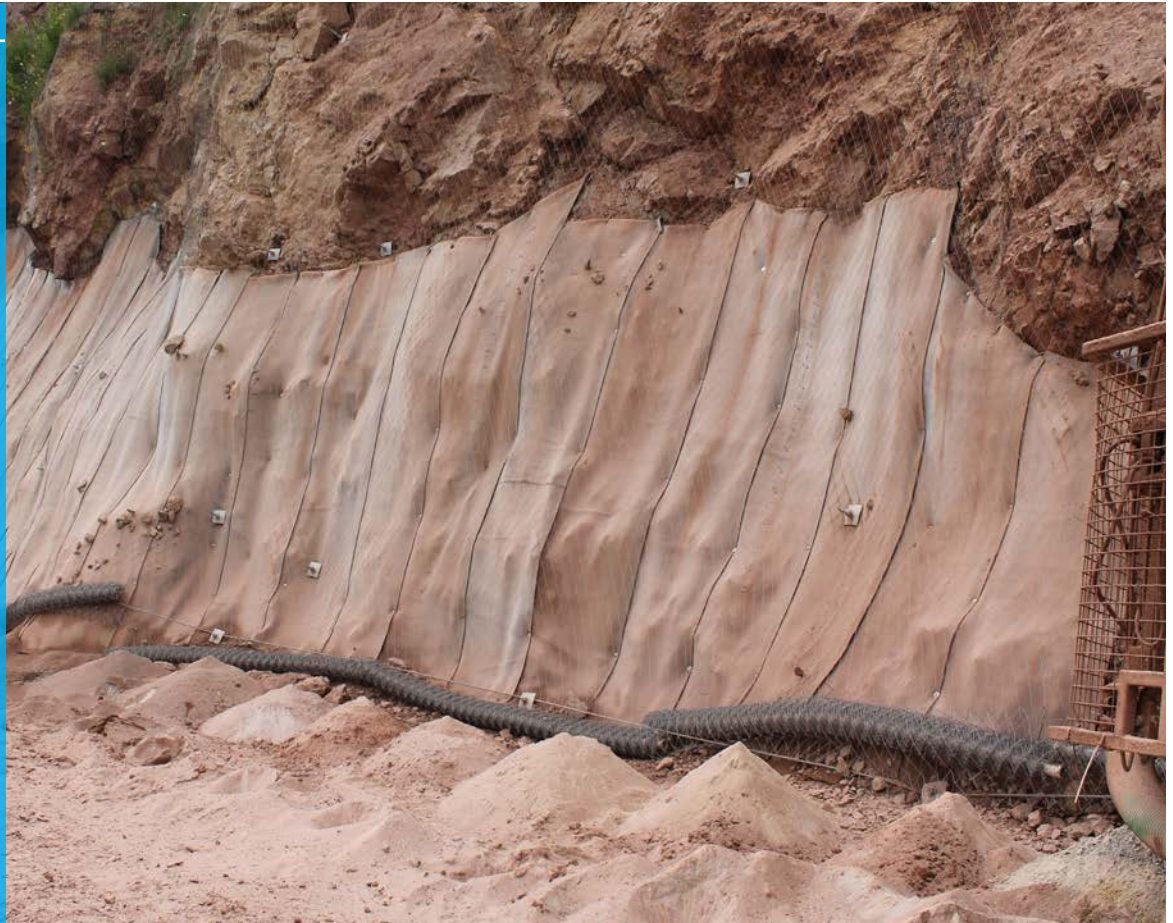
Completed section of slope lined with CC5

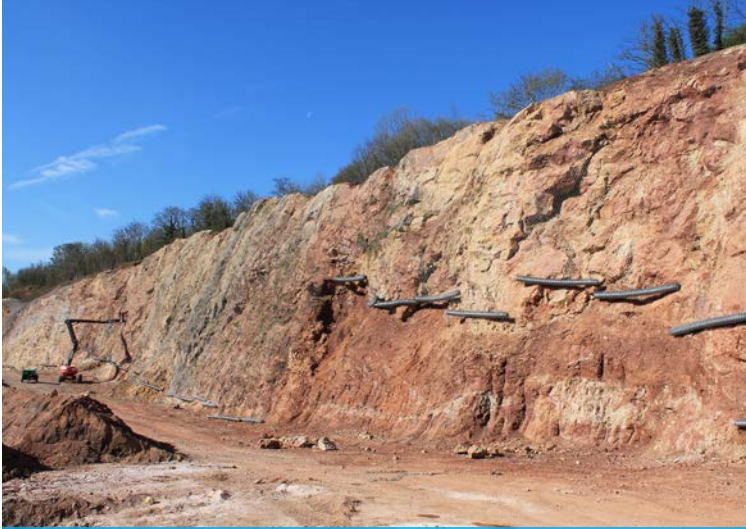
The installation site was suffering from severe surface erosion

In May 2013, Concrete Canvas (CC) was trialled as an alternative to shotcrete to provide surface erosion protection to sections of sandstone overburden at a limestone quarry site in Derby, UK. Reinforcing the sandstone overburden would allow the quarry site to conduct additional excavation and blasting, maximising the potential yield of the site and helping to ensure its continued operation for an additional 10 years.

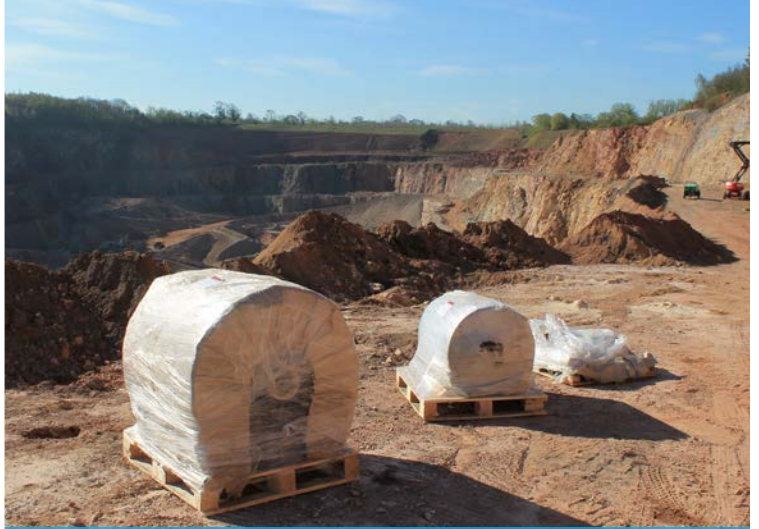
CC8 delivered to site in bulk rolls

CC8 bulk rolls of 125sqm were delivered to site and suspended from spreader beam equipment using a 3.5T telescopic forklift. The CC was batched to specific lengths to match individual heights from the ground level to the top of the overburden using a cut-off saw. This ensured that there was no wastage as each length was tailored to match the rock face exactly. Using a rough terrain cherry picker, each length was then initially hung from the top onto the rock face using 250mm steel ground pegs, folding the top edge by 50mm to ensure a neat termination and to reduce the risk of water ingress between the CC and the substrate. Subsequent layers of CC were then positioned with an overlap of 100mm to the adjacent layer. These overlapped sections were then screwed together with 30mm stainless screws at 200mm intervals using an auto-fed screwdriver. The CC layer was then secured to the rock face at 2m intervals along the overlaps and at void points using 100mm long rock bolts with 20mm washers to ensure intimate contact between the CC and reduce void spaces. Once the CC had been secured, it was then hydrated using water from a 4000 gallon dust suppression tank. Post set, the CC layer was draped in Geobrug Deltax wire mesh and the rock face stabilised using a GEWI thread bar system with load bearing plates and nuts.

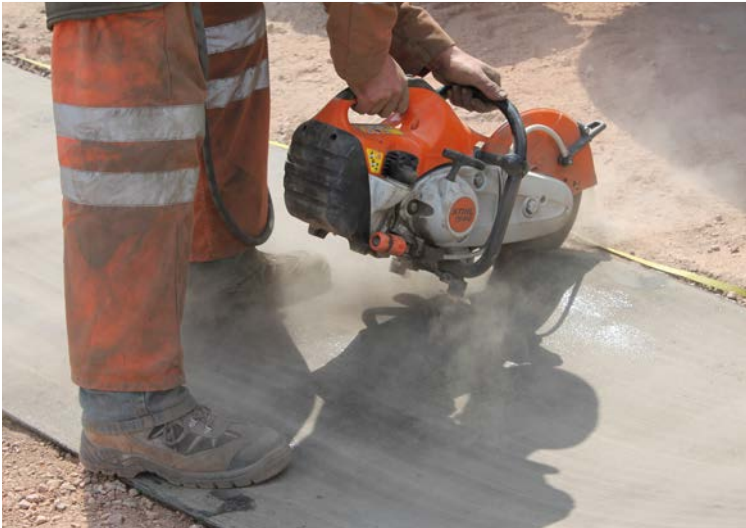
Unset CC8 cut to length using a disk cutter

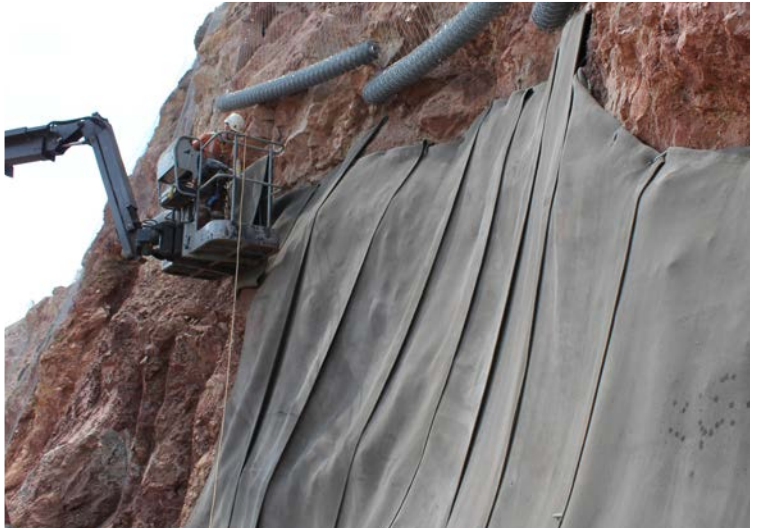
CC8 hung from top of rock face using 250mm steel ground pegs

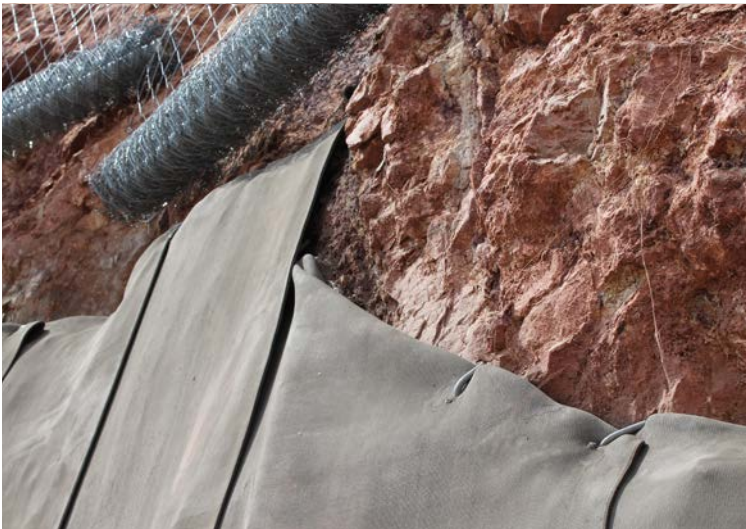
Adjacent lengths of CC overlapped by 100mm

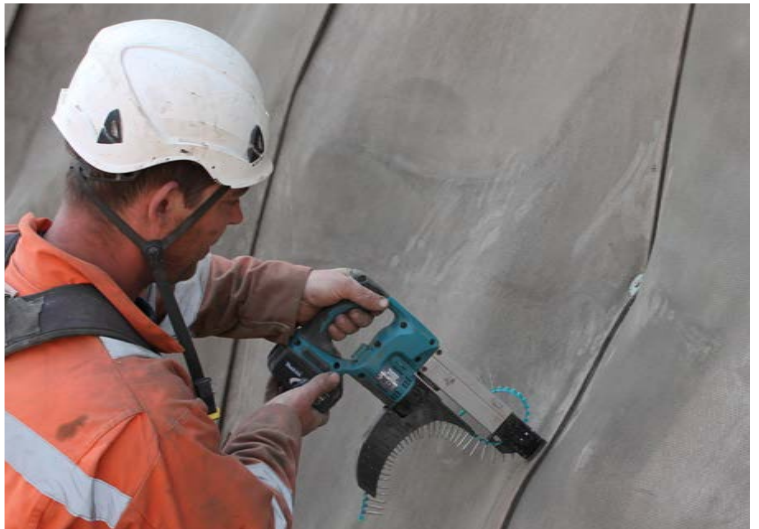
Adjacent lengths of CC fixed using autofeed screwdriver

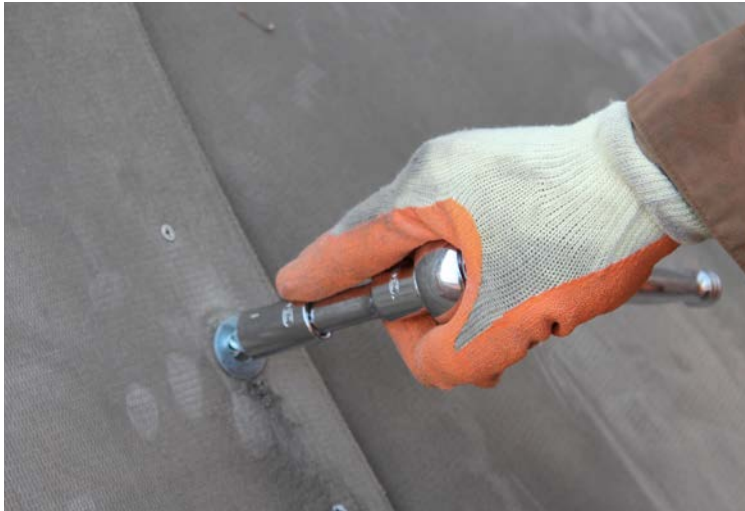
CC fixed to rock face at 2m intervals using 100mm rock bolts

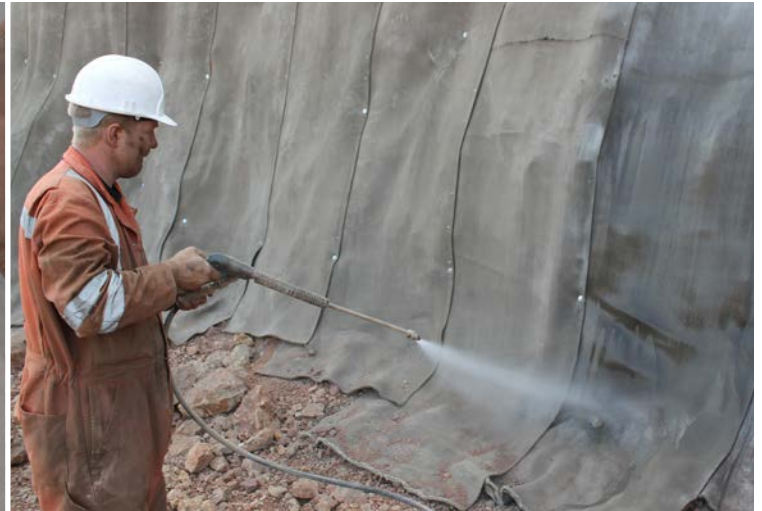
CC hydrated water from a 4000 gallon dust suppression tank

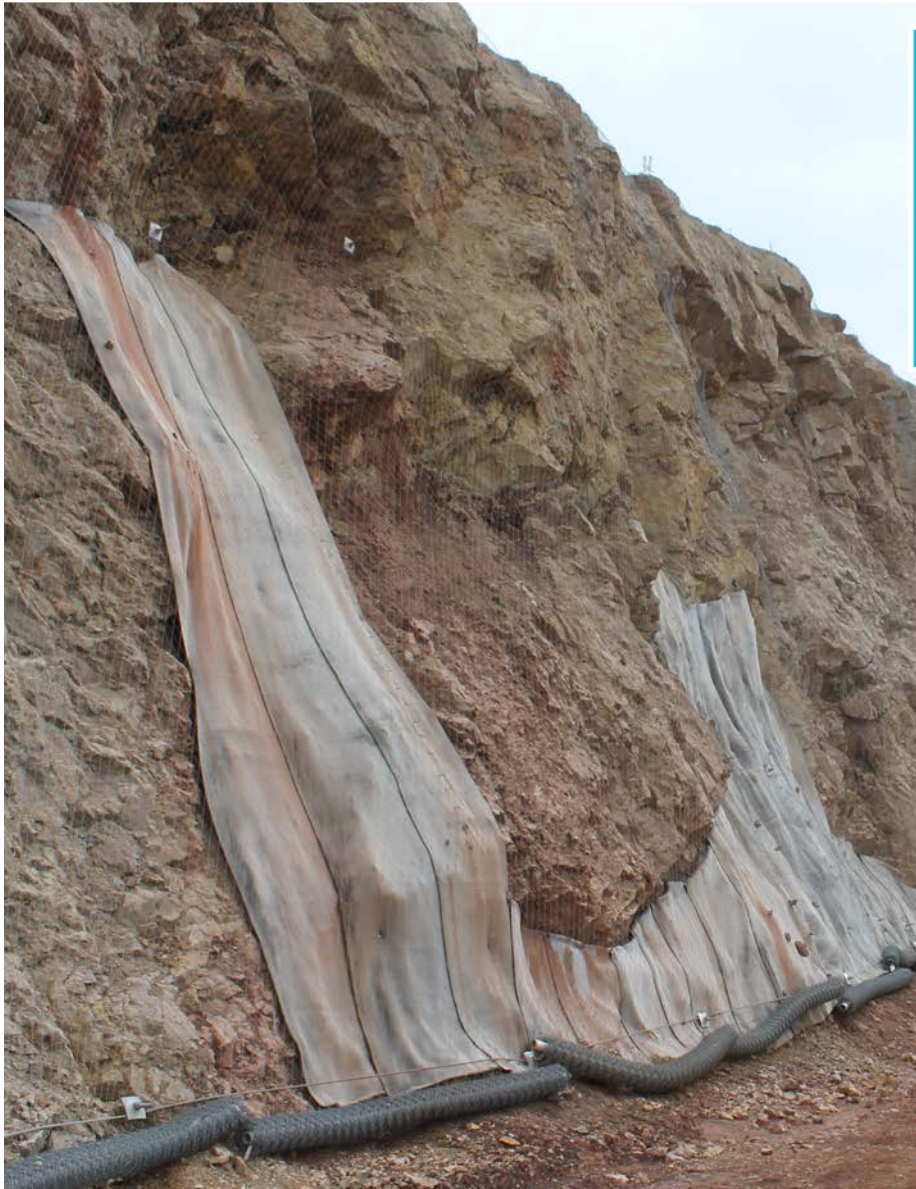
Post-set CC was draped in a wire mesh and the rock face stabilised using a thread bar system. Sections of slope were later blasted.

Successful blasting of the rock face took place two weeks later with no signs of slope deterioration from either blast or the period of weathering since installation. Concrete Canvas also proved to be **60% less expensive** than the traditionally used shotcrete option and saved Breedon Aggregates over £14,000. **The 335sqm trial installation was completed in two days using a crew of three.**
